History and structural features

After many years of temporary repair, the decision was made to fully restore the wooden Ponte degli Alpini bridge in the Veneto region of Italy. GDI gains in insight into the complexity of the piling work needed as part of the project

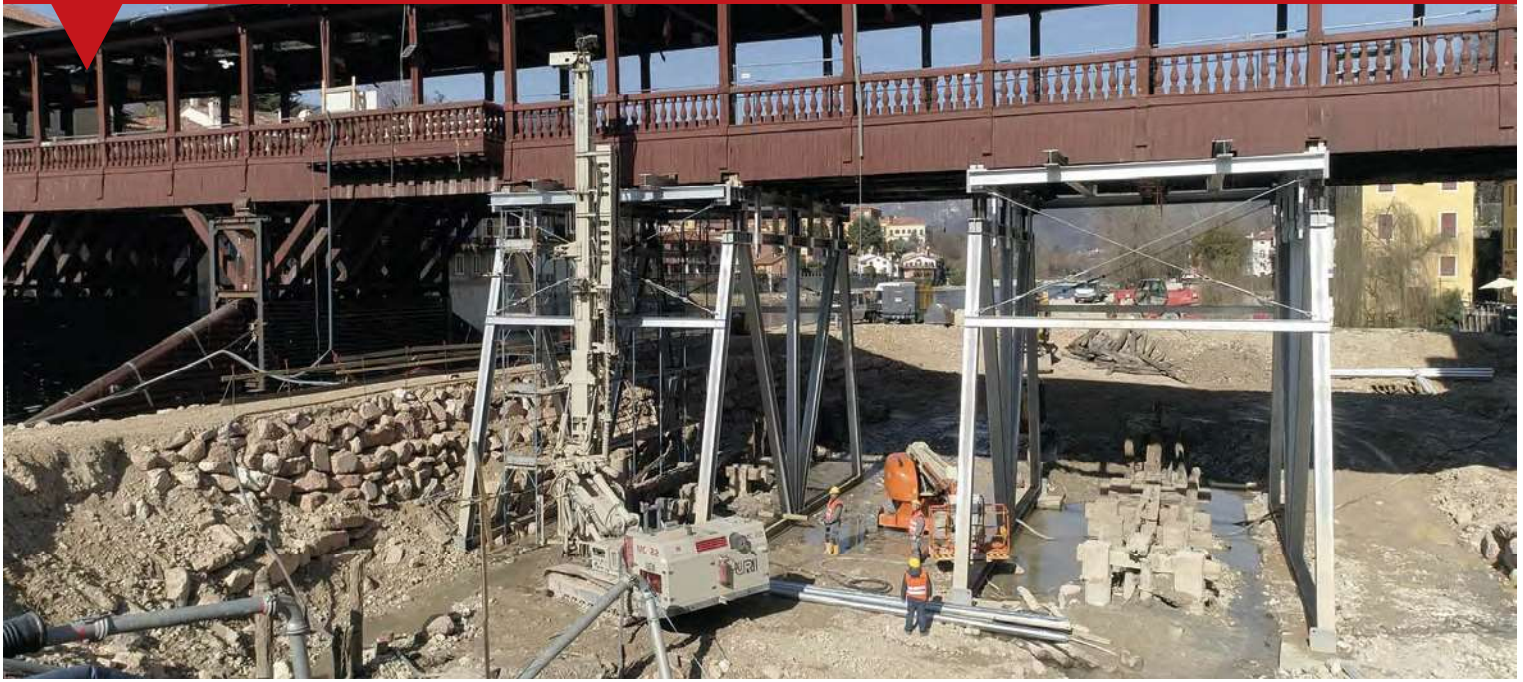
Above: A steel frame work was used to support the wooden Ponte degli Alpini bridge while the two underlying bents were completely removed, allowing the construction of the remaining foundation micropiles for the starlings and the installation of the stainless steel truss structure supporting the bents

With the steel framework supporting the deck, the two underlying bents were completely removed, allowing the construction of the remaining foundation micropiles for the starlings and the installation of the stainless steel truss structure supporting the bents. A total of 50 micropiles cased with stainless steel tube in the upper section were constructed to accommodate the timber poles of the starlings.

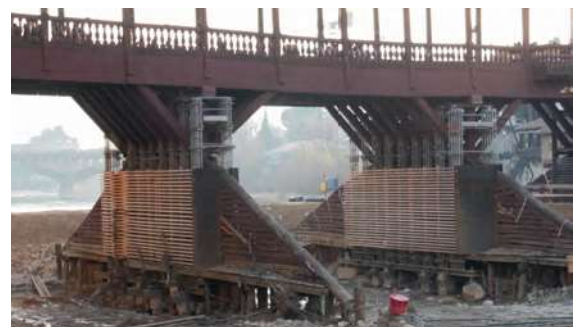
After years of water erosion the bridge's original wooden foundations were so weak the bridge was beginning to sink

Despite all these measures, the horizontal loads of the water flow and the deterioration of the underwater timber elements of the bridge have caused, in recent years, critical deformations of the bridge foundations.

The reinforcing foundation elements introduced from 1965 to 1990 were no longer able to support, through the severely deteriorated timber ground beam, the vertical loads transferred from the four bridge bents.

Starting in 2013, the sinking of the bridge structure became evident. In the summer of 2015, the bridge was sinking by an average of 4-5cm per month, putting the bridge at serious risk. The further collapse of one of the bents in 2018 caused the bending of the bridge. Temporary works were deployed to prevent further damage and avoid the closure of the bridge. Major restoration could no longer be postponed.

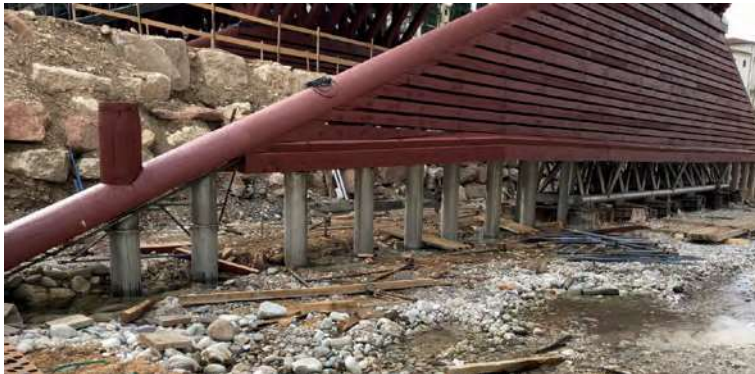
After installation, the new steel micropiles were then clad with wood to replicate the look of the bridge's original design

Further foundation works focus on the starlings: due to the poor state of preservation of the timber piles, they will be replaced by micropiles with permanent stainless steel casings in the upper section. The portion of the starlings above water level will be rebuilt using new timber as well as original timber where possible.

The new steel elements introduced by the project will remain under the water level and/or hidden from view thanks to the filagne covering the bents, which will be reconstructed according to original specifications. In this way, the project aims to tackle the structural problems that have endangered the bridge throughout the centuries, while preserving the original form and character of the iconic masterpiece by Palladio.
