# Foundation DRILLING

JULY 2017

**Moretrench Micropile  
Foundation Systems  
Aid in New York State  
Flood Mitigation**

## Moretrench Micropile Foundation Systems Aid in New York State Flood Mitigation

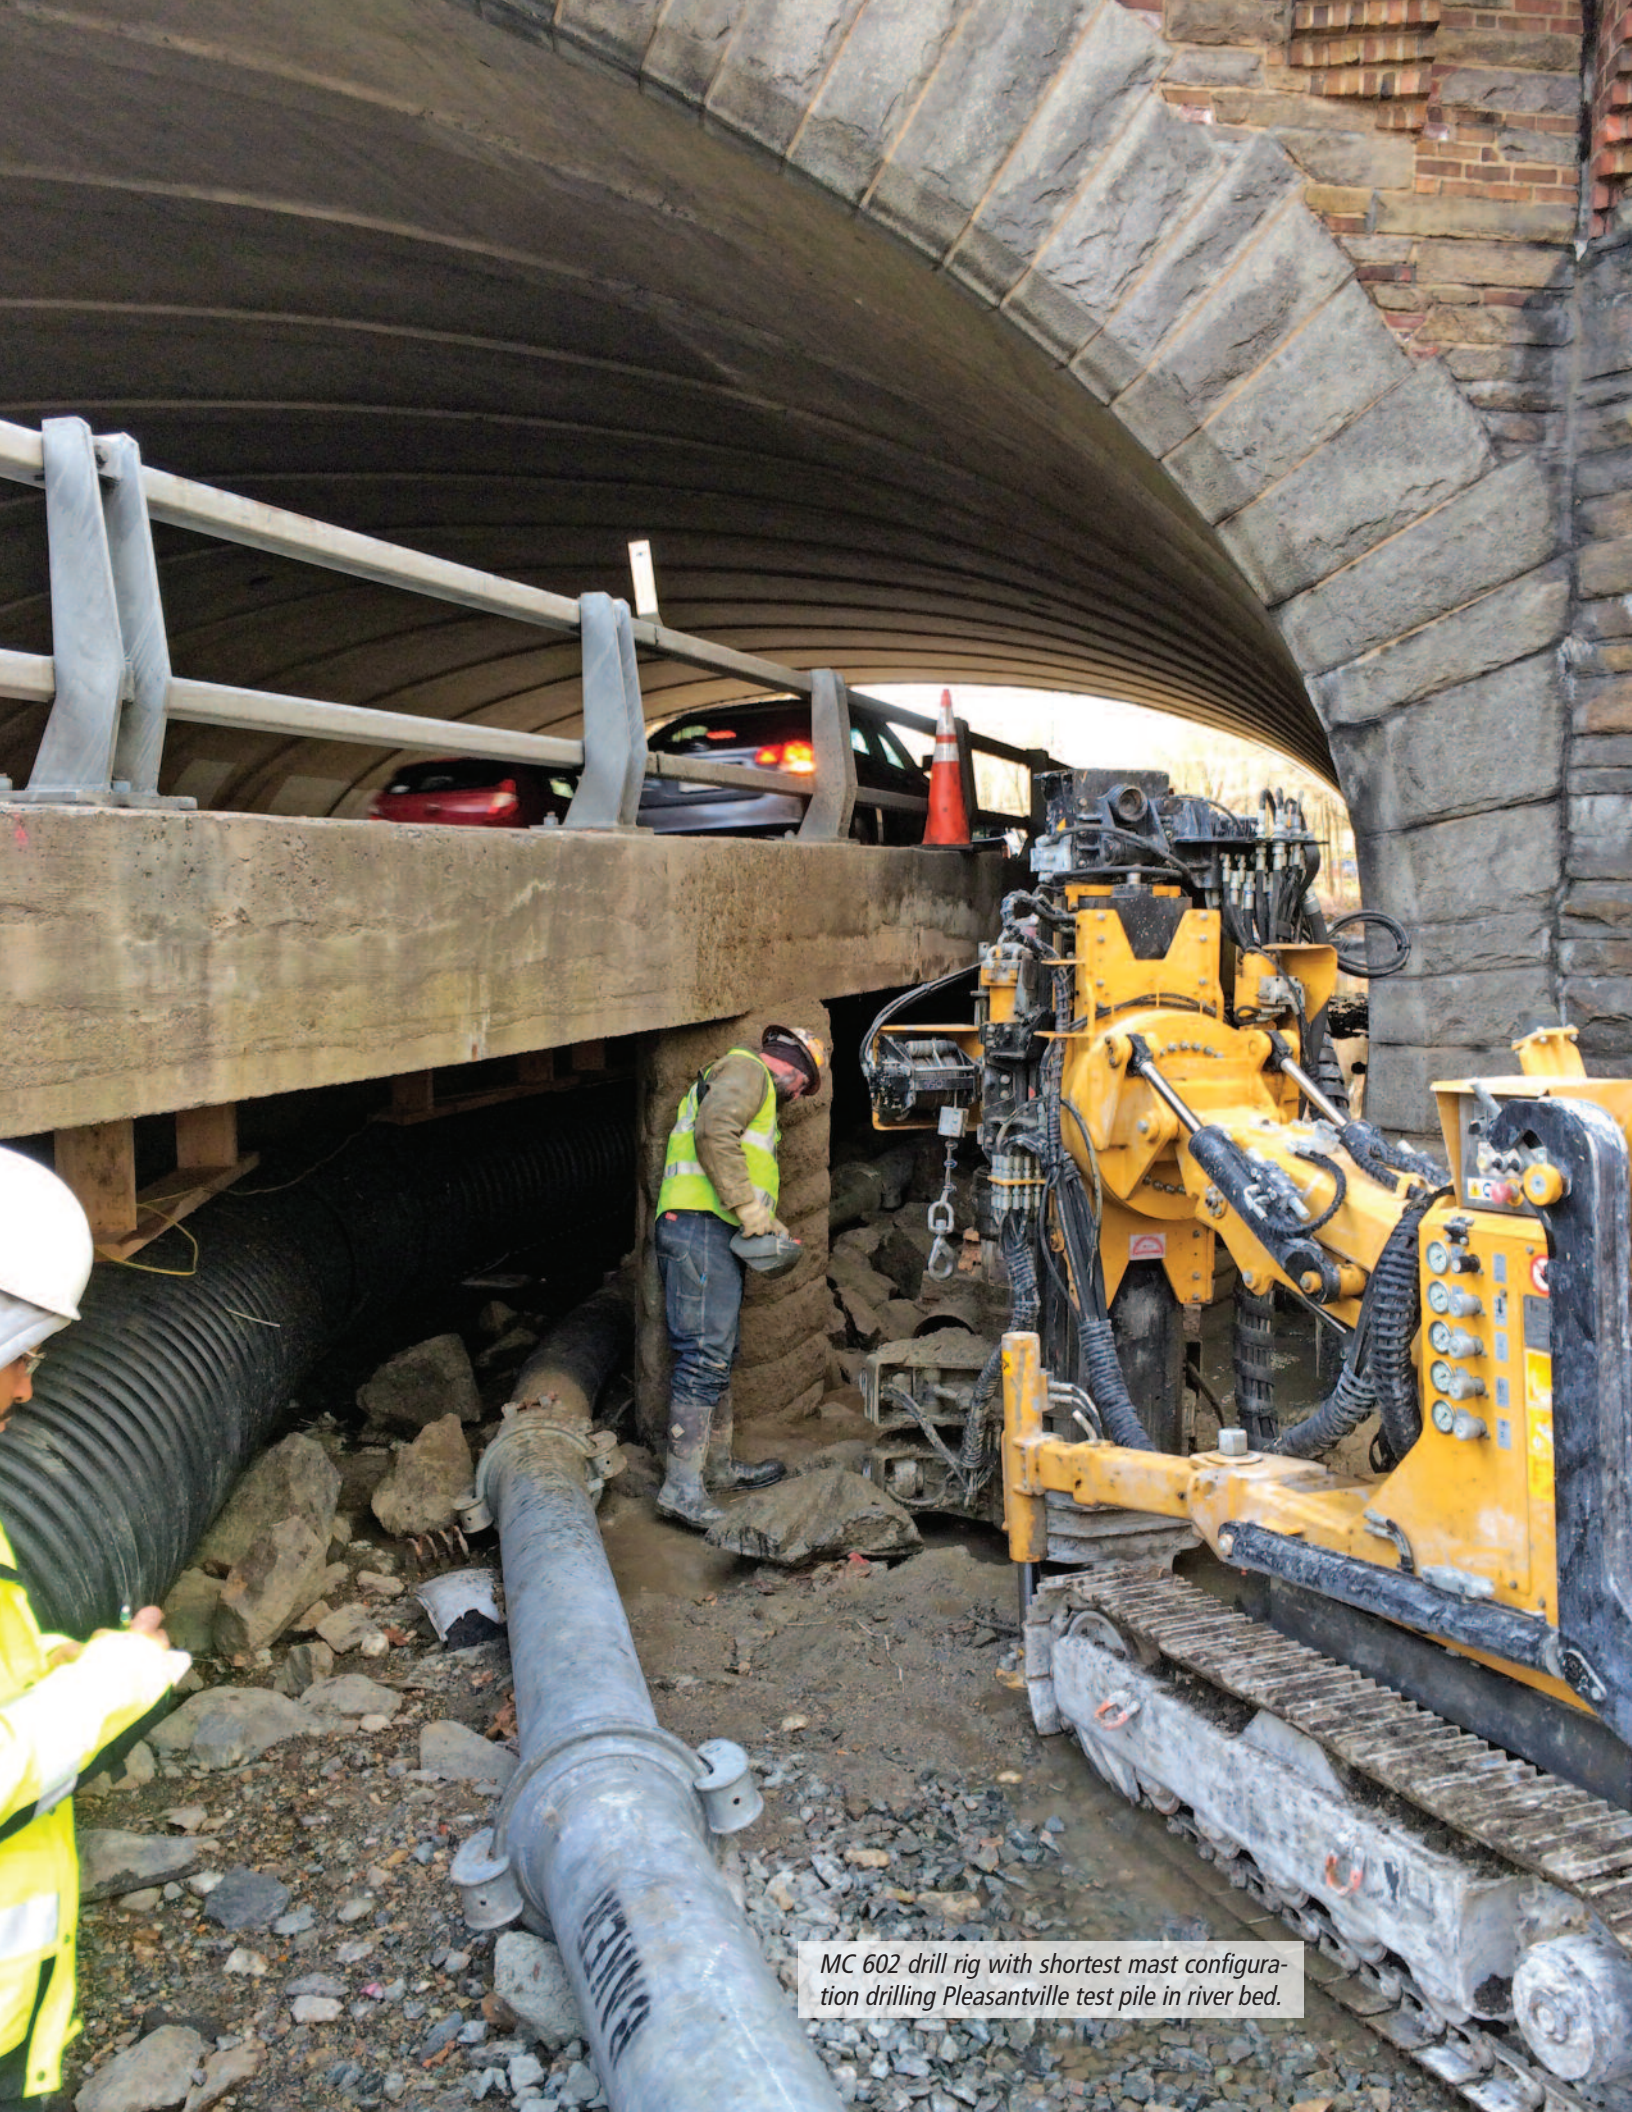
*MC 602 drill rig with shortest mast configuration drilling Pleasantville test pile in river bed.*

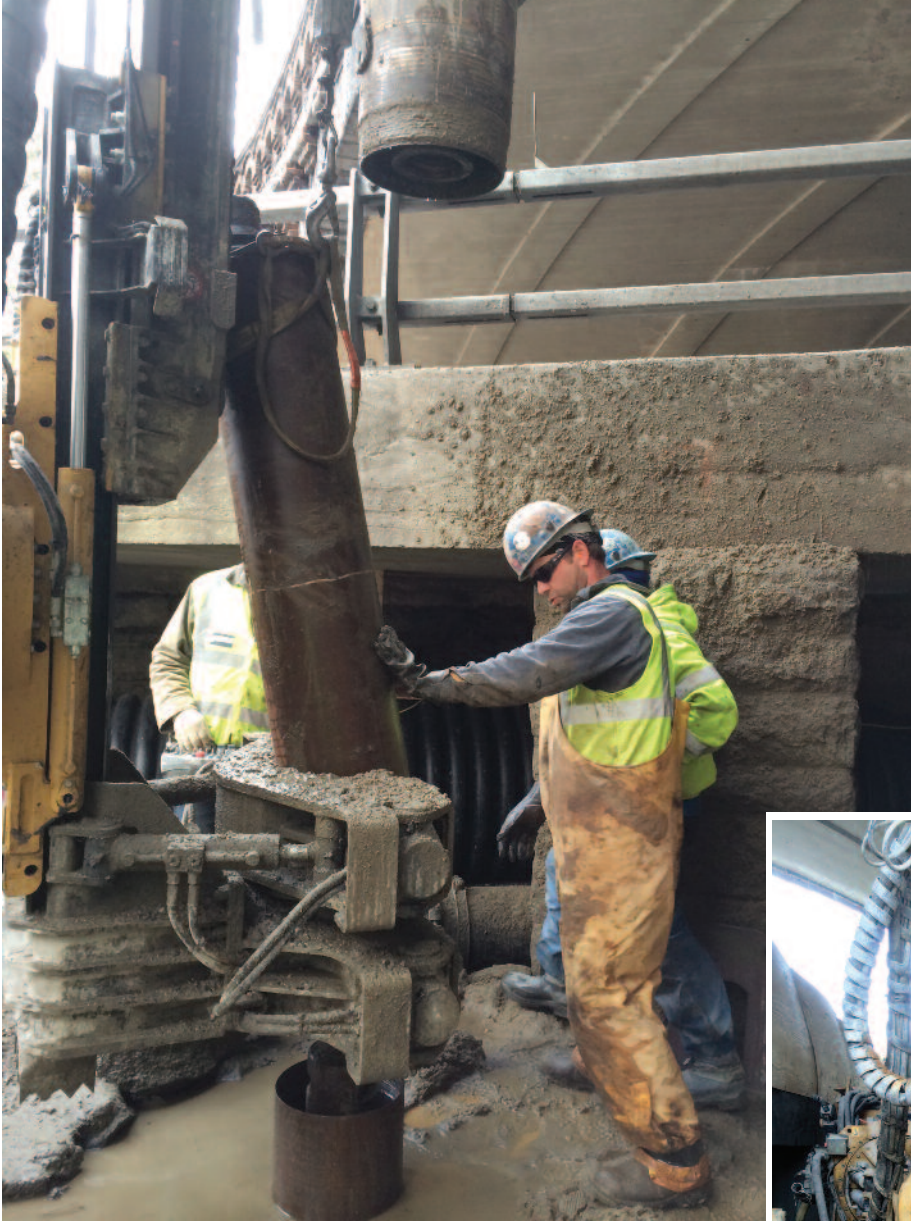
*Dockbuilders working the front of the MC 602 to add another section of casing.*

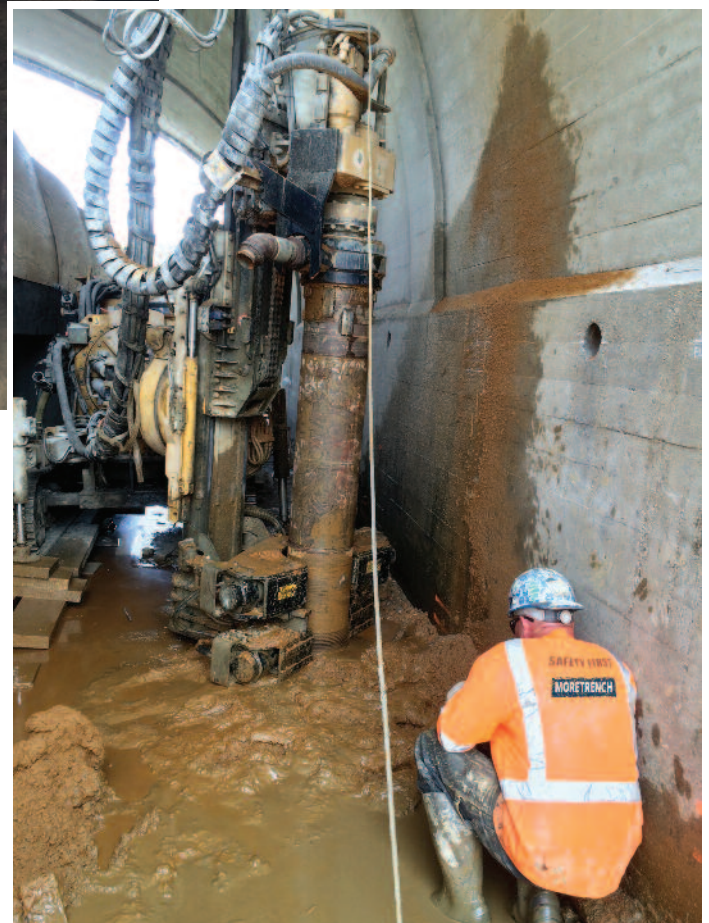
*Dockbuilder signaling the driller to line up the 3-in. long threaded joint during drilling of gravels within the tight constraints and slippery work surface associated with the river-bearing piles.*

During the design stage, the selection of the 3-in. long threaded joint did not appear to have any construction impacts; this was not the case in the field. In tough drilling situations, i.e. the rounded river gravels, the extra-length thread presented quite a challenge for the drill crew. While drilling through the gravels, the drill rig's alignment could be thrown off the pile location and thus disturb the alignment with the threads. While a typical thread length is 2.5-in. in length, the 3-in. length was not as forgiv-

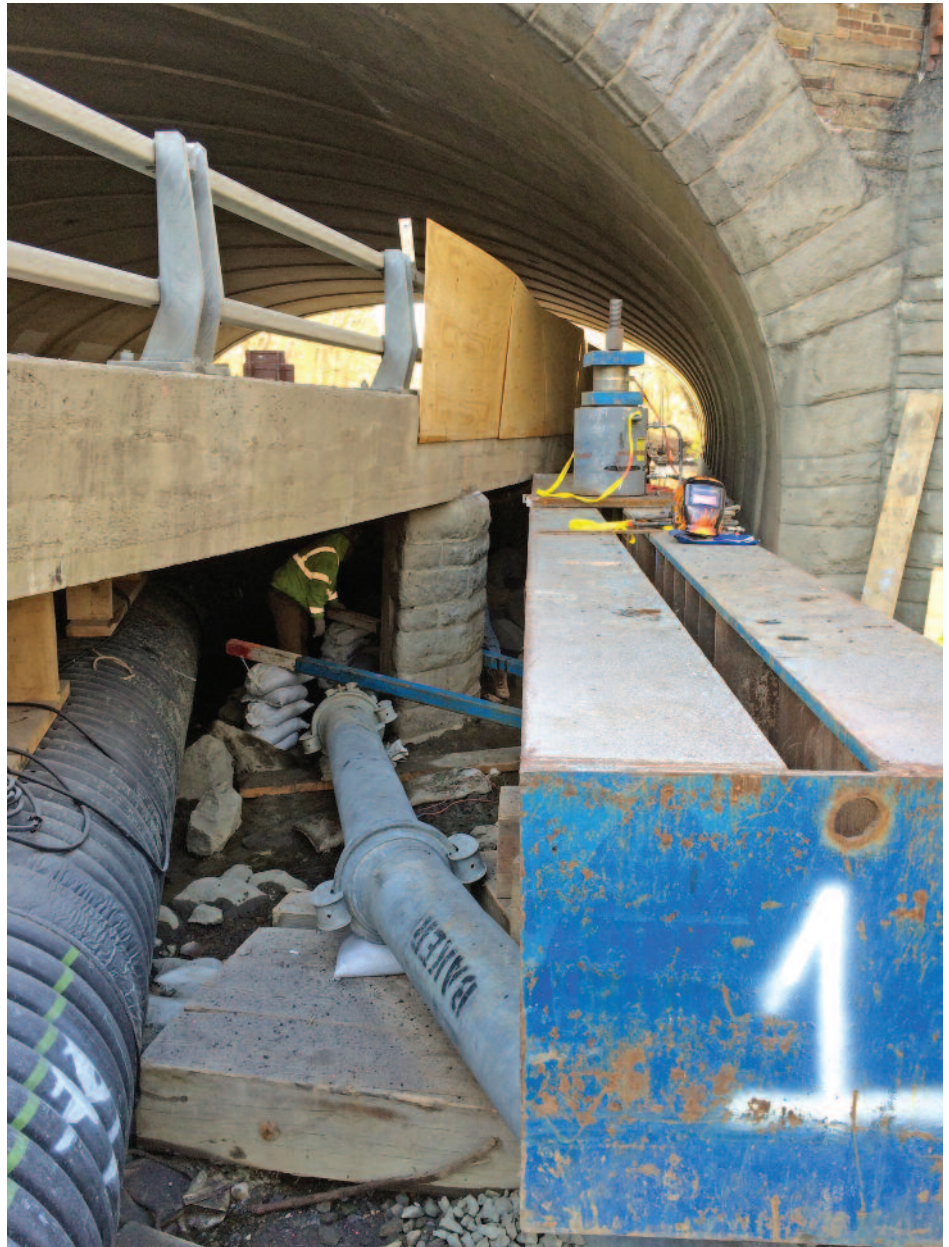
*Tension load test underway in Pleasantville river bed. Note the diverted river piping and guardrail protection.*

At Pleasantville the test first ran up to 200% of the 53-ton design load, then an attempt was made to load the pile to failure; however, at 300% loading the cribbing towers failed prior to pile failure. The test was nonetheless successful, verifying the 20.5-ft. bond length was appropriate for soil.

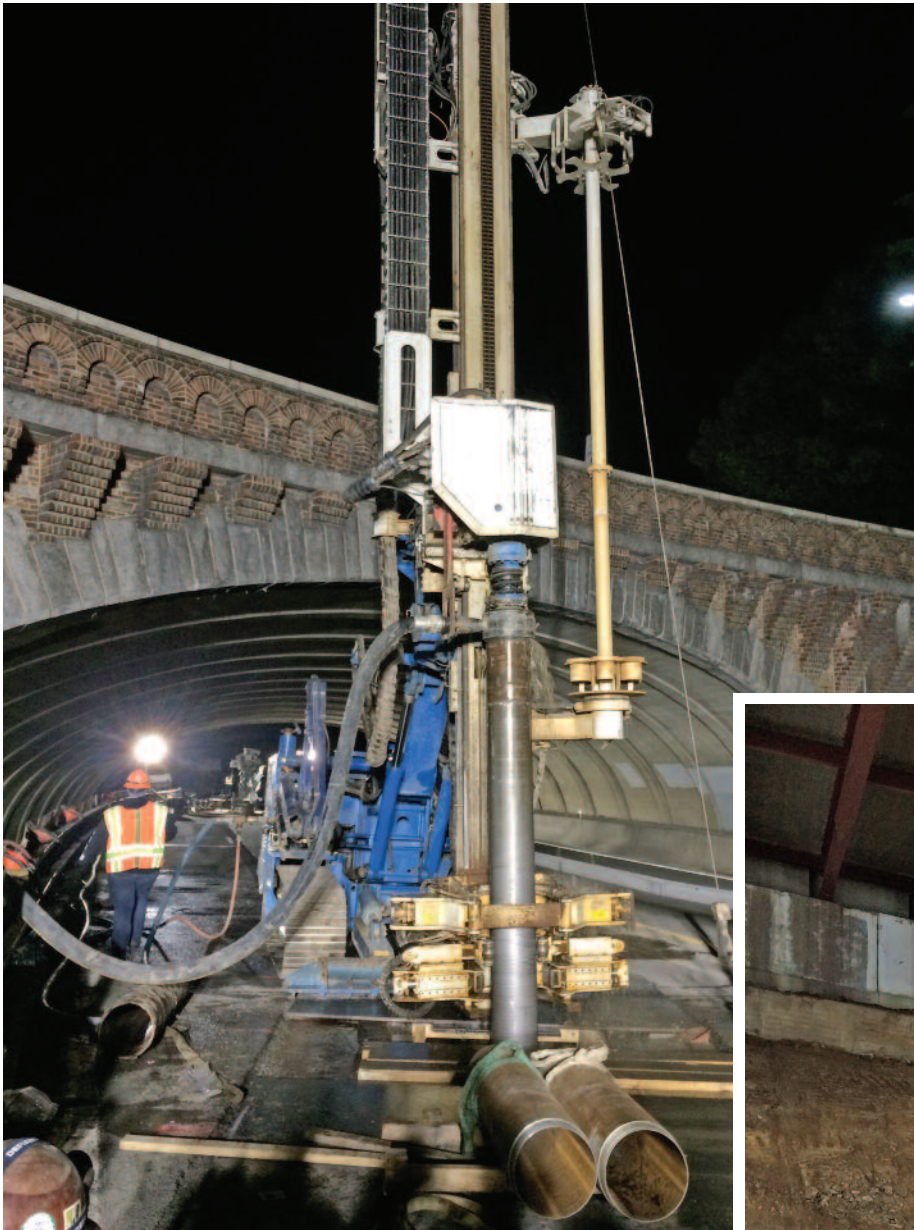
*MC 1200 rig drilling the few abutment piles with no headroom restriction.*

The abutment piles were drilled from the Saw Mill Parkway roadway during night work under a Parkway closure. The majority of the piles were drilled with a low headroom rig to allow access underneath the overhead stone arch bridge, but the few piles that were outside of the overhead footprint were installed using a much larger MC 1200 drill rig to expedite the schedule and increase the production. Moving the equipment on and off the Parkway each night was well coordinated by ECCO and minimal downtime was achieved. ECCO also devised a road plate system that fit together like a puzzle along the alignment of the abutment. This allowed for controlled spoils clean-up below the roadway elevation and covered

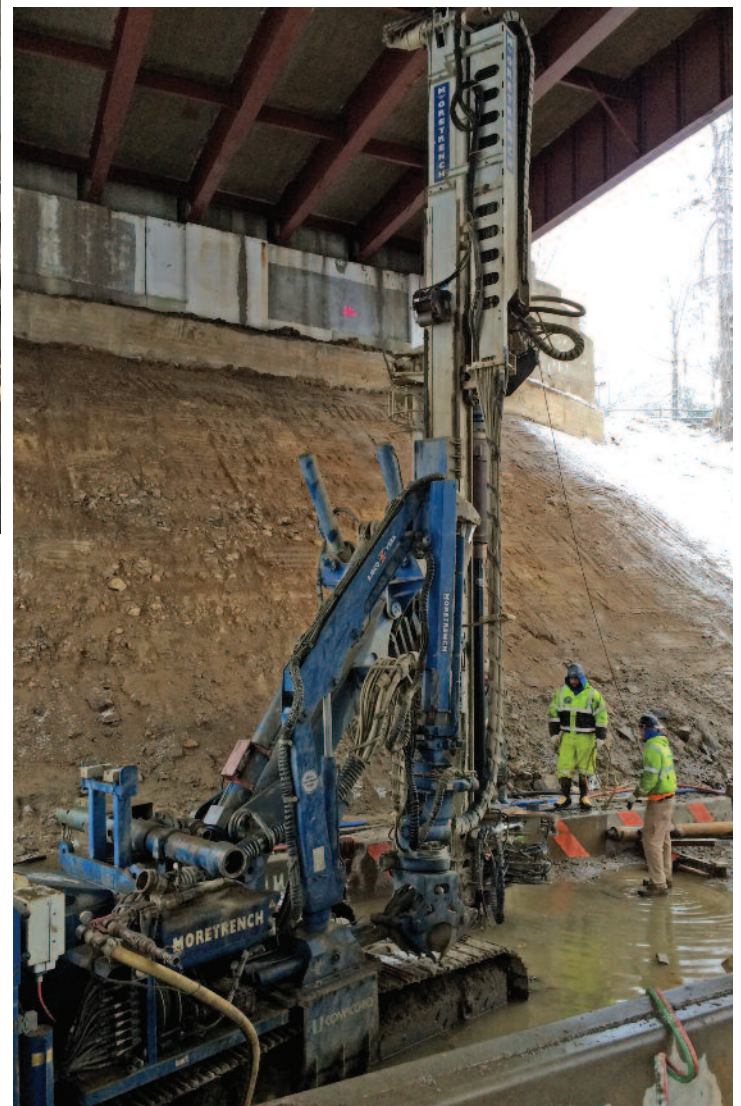
*Moretrench's MC 1200 working beneath the Kisco bridge where more headroom was available.*

Since more working room was available at Mount Kisco than the other two locations, Moretrench was able set up the drill rig with a specific length of mast to physically fit under the existing bridge, yet provide enough stroke to install 10-ft. lengths of 12.75-in. diameter casing. The drill rig had to be tracked into the excavated trench of the proposed abutment at the water table depth, with sump pumps working to control the water. The main challenge was to work with a large rig inside a narrow trench in between existing columns and an existing embankment. The design called for both plumb piles and 1H:6V battered micropiles to handle some of the abutment lateral loads, which added to the difficulty of the site logistics.

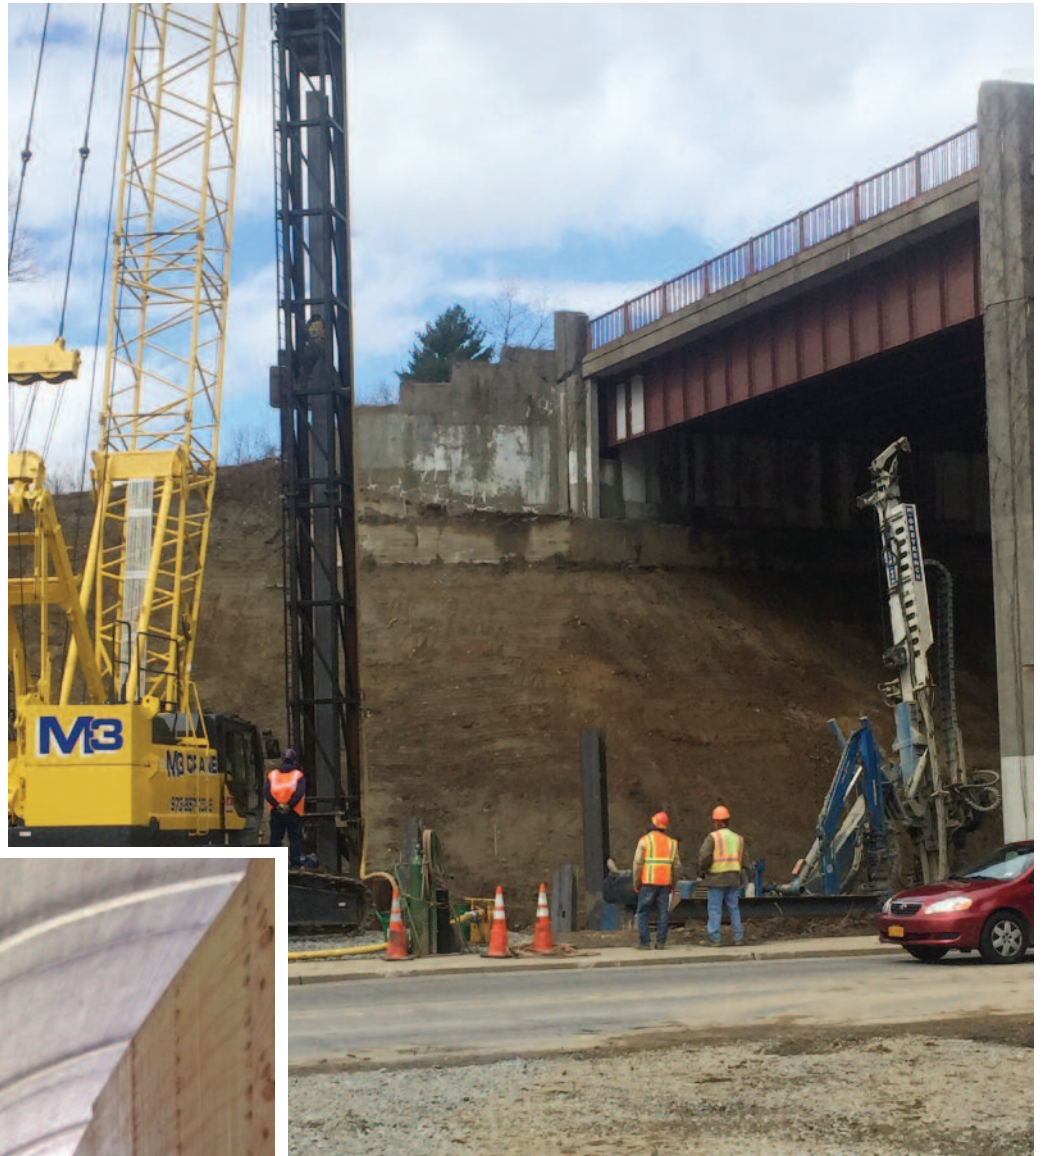
*ECCO III driving H-piles while Moretrench's MC 1200 installs battered piles under the Kisco bridge.*

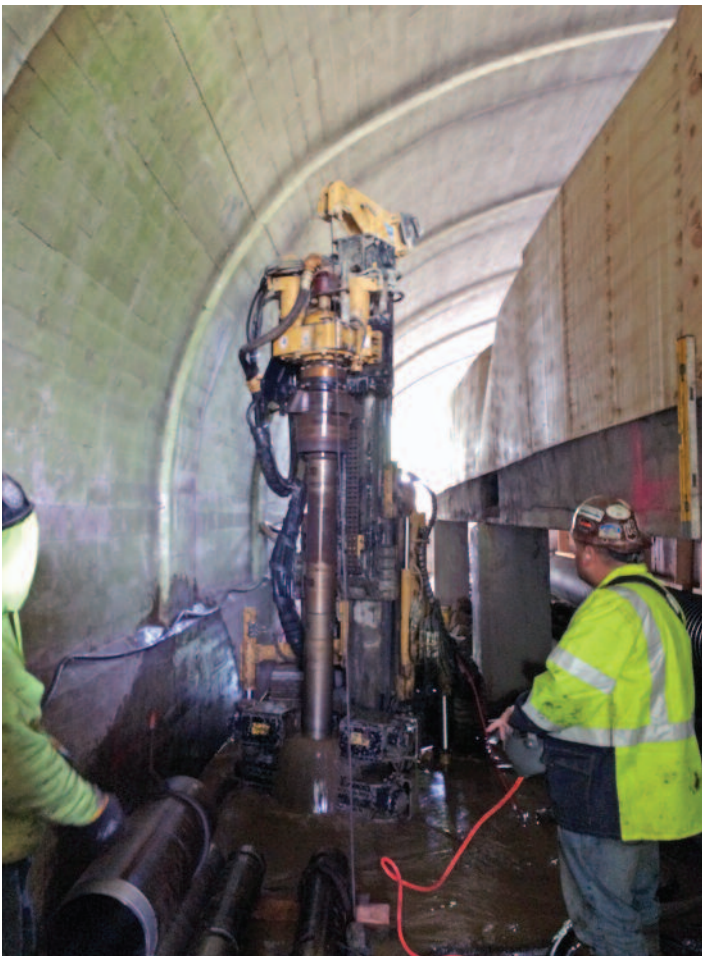
*Working within the confines of the Bedford stone arch bridge next to active traffic lanes.*

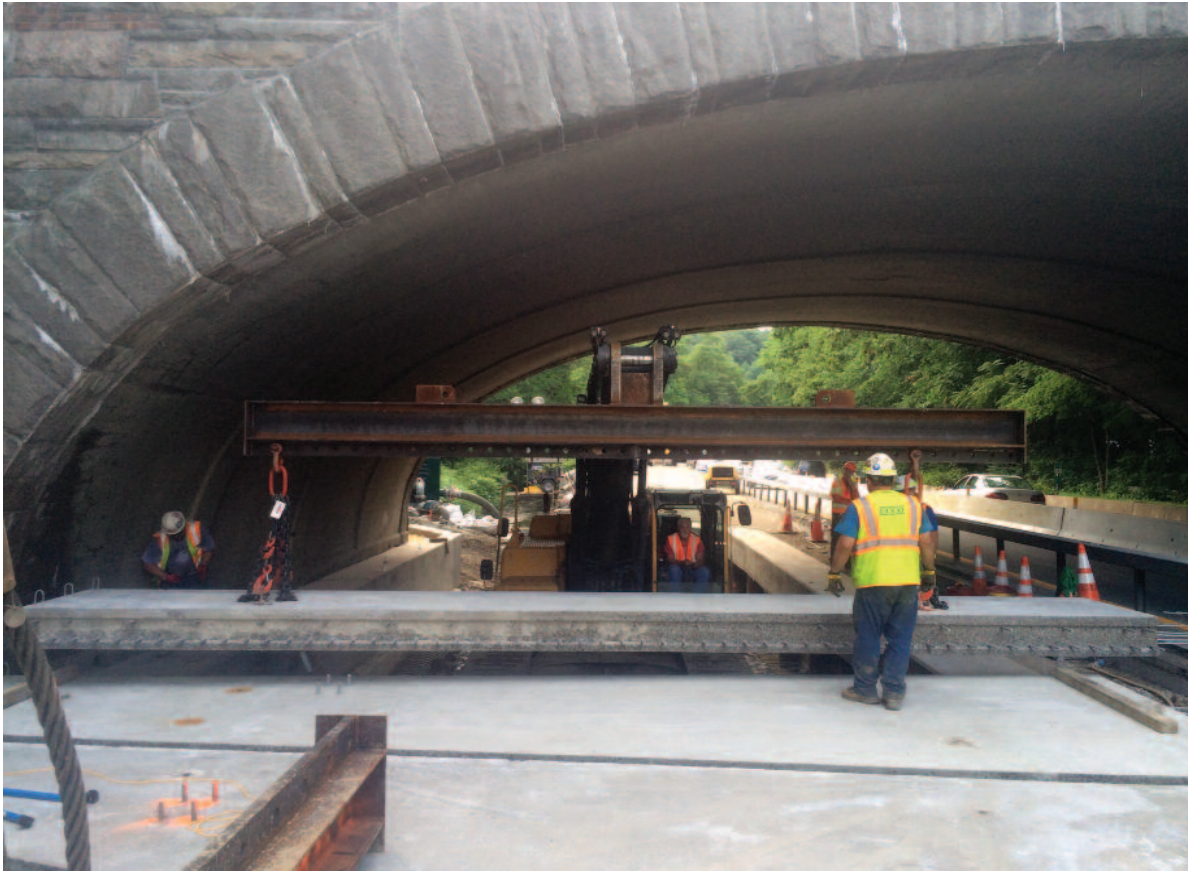
*ECCO III setting superstructure precast concrete slabs.*

With all the pile supported substructure elements in place, the superstructure phase could begin. During this phase, southbound traffic was reduced to one lane and detoured onto the northbound left lane for the full 24/7 detour, which was allowed for 21 days. During this period, ECCO demolished the existing bridge, set the new superstructure precast concrete slabs, formed and poured Ultra High Performance Concrete that join the slabs together, and completed all other miscellaneous roadwork including guide rail, asphalt paving, concrete approaches, and striping. Once this work was completed, traffic was restored to the original configuration ahead of schedule.
